# FATIGUE BEHAVIOUR OF A ROLLED AZ31 MAGNESIUM ALLOYS PREPARED BY EP AND BB CONDITIONS

Abstract: Rotating bending fatigue tests have been performed using smooth specimens of a rolled AZ31 magnesium alloy in laboratory air at ambient temperature. Fatigue strength and characteristic was evaluated and fracture mechanism was discussed on the basis fracture surface analysis. Electrical polishing (EP) as well as deep rolling (ball burnishing (BB)) U-notched specimens were performed on two groups of samples, to evaluate optimum conditions for fatigue life. The microstructure and tensile properties of roll cast (RC) Mg- 3% Al- 1% Zn (AZ31) was investigated. The fatigue strength of 107 cycles around 100 MPa for deep rolling while it was around 40 MPa for Electrical polishing. It was very important to understand the effect of (ball burnishing (BB)) conditions on the hardness of the surface through to the core. The two procedures improved the fatigue performance, but better improve in results were found in ball burnishing. The growth of small cracks initiated at the surface coincided with the FCP characteristic after allowing for crack closure for large cracks, but the operative fracture mec

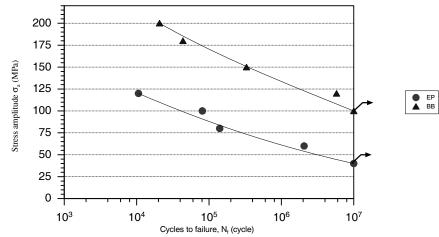
Fig.2. S-N curve for rolled AZ31 at EP,BB conditions, rotating beam, R=-1, 50Hz.

S/N curves for the EP and the BB specimens in laboratory at a stress ratio of -1 and frequency of 50 Hz (rolled magnesium alloy) in laboratory air is shown in Fig. 2. In this figure, for comparison purposes, the S-N curves of the EP and BB specimens are shown respectively. As seen from the figure, the fatigue life of the rolled magnesium alloy of EP specimen is relatively shorter than that of BB specimen. The extent bending in the S-N curve is gentler in the BB specimens than in the EP specimen. Next let us compare the S-N characteristics of the EP and BB specimens. There are great differences in the fatigue lives and in the fatigue limits, especially at higher stress amplitudes, there are differences in the fatigue lives.

The fracture surface of AZ31 for EP condition and BB condition at different stress is shown in Fig. 4. Subsurface crack initiation occurred at applied stresses at 60 MPa. At BB condition but it can be seen for both 80 and 100 MPa stress for EP condition. The S–N diagram is shown in Fig. 2. It is well known that fatigue limit does not exist in non-ferrous alloys, thus fatigue tests were continued until 10<sup>7</sup> cycles. At EP condition  $\sigma$ = 40 MPa, fatigue failure did not occur, but non-propagating cracks were observed on the specimen surface. As can be seen in the figure, the present Mg alloy seems to possess a definite fatigue limit, which may be related to the existence of non-propagating cracks. The fracture mode depending

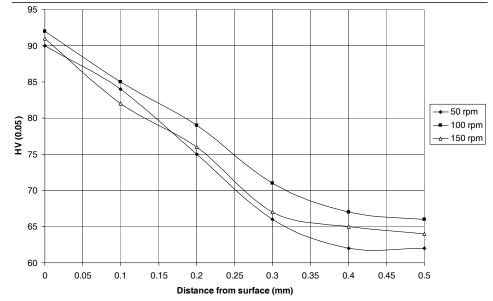
Fig. 3. Microhardness profile oif AZ31 after BB at 200 bars, 0.17 mm/min at different BB rotation speed.

**3. 3.** A different experiment were used to investigate the best condition for BB (pressure, feed rate, speed) as example for tool HG3 200 bar (123 N) for 50, 100 and 150 rpm. The microhardness measurement from the surface in Fig. 3. Shows that the suitable condition for using 200 bars is 100 rpm for AZ31 as the hardness decreased from the circumference gradually to the center.

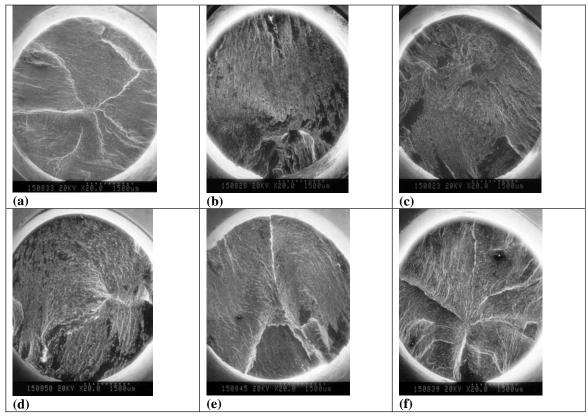
**Fig.4.** SEM micrographs showing fracture surfaces at difference stress for EP at (a) 60MPa; (b) 80 MPa; (c) 100 MPa and BB at (d) 60MPa; (e) 80 MPa; (f) 100 MPa.

on applied stress level, above 60 MPa cracks initiate at the surface (surface fracture), while below that stress at the interior of the specimen (subsurface fracture). Subsurface fracture is a very interesting finding, which has not been recognized in Mg alloys, for both EP and BB conditions.

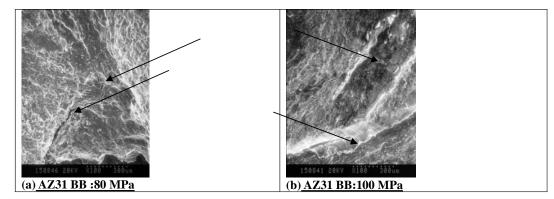
Fig. 5. SEM micrographs showing cracked surfaces at difference stress for BB at (a) 80MPa; (b) 100 MPa

The cracked line could be seen easily for higher stress for BB condition as fracture occurs in internal surface not at the outer surface as in the EP condition in Fig. 5.
