# FATIGUE BEHAVIOUR OF A ROLLED AZ31 MAGNESIUM ALLOYS PREPARED BY EP AND BB CONDITIONS

Y. Fouad

Faculty of Engineering and Materials Science, German University in Cairo, Cairo.

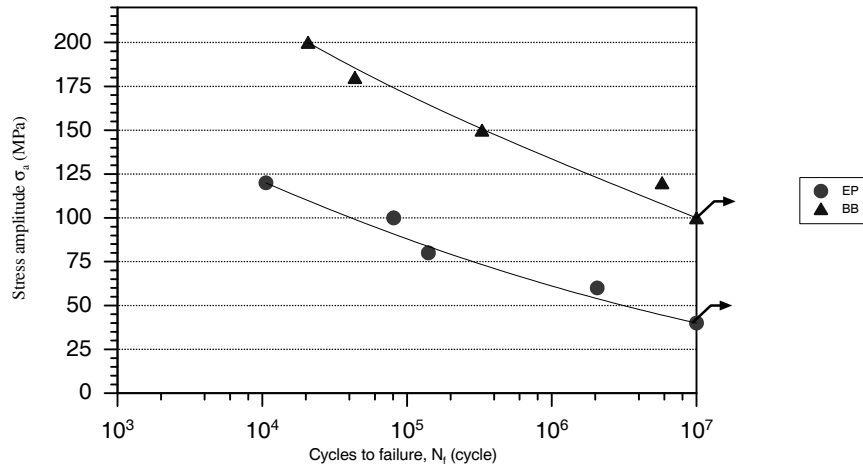
**Fig.2.** S-N curve for rolled AZ31 at EP,BB conditions, rotating beam, R=-1, 50Hz.

S/N curves for the EP and the BB specimens in laboratory at a stress ratio of -1 and frequency of 50 Hz (rolled magnesium alloy) in laboratory air is shown in Fig. 2. In this figure, for comparison purposes, the S–N curves of the EP and BB specimens are shown respectively. As seen from the figure, the fatigue life of the rolled magnesium alloy of EP specimen is relatively shorter than that of BB specimen. The extent bending in the S–N curve is gentler in the BB specimens than in the EP specimen. Next let us compare the S–N characteristics of the EP and BB specimens. There are great differences in the fatigue lives and in the fatigue limits, especially at higher stress amplitudes, there are differences in the fatigue lives.

4. Subsurface crack initiation occurred at applied stresses at 60 MPa. At BB condition but it can be seen for both 80 and 100 MPa stress for EP condition. The S-N diagram is shown in Fig. 2. It is well known that fatigue limit does not exist in non-ferrous alloys, thus fatigue tests were continued until  $10^7$  cycles. At EP condition  $\sigma = 40$  MPa, fatigue failure did not occur, but non-propagating cracks were observed on the specimen surface. As can be seen in the figure, the present Mg alloy seems to possess a definite fatigue limit, which may be related to the existence of non-propagating cracks. The fracture mode depending
